# Cibolo Creek Watershed Data Report

August 2014

**THE MEADOWS CENTER**  
FOR WATER AND THE ENVIRONMENT

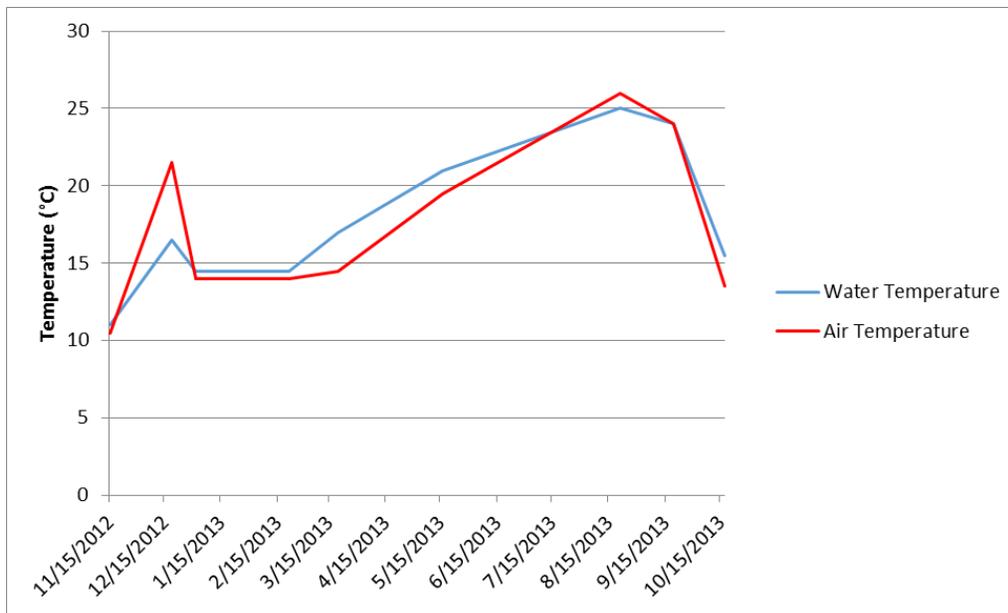
Air and water temperatures were taken 9 times at this site. The mean water temperature was 17.7°C and ranged from a low temperature of 11°C in November, 2012, to a high 25°C in August, 2013. The air temperature ranged from a low of 10.5°C in November of 2012, to a high of 26°C in August, 2013.

**Figure 22: Air and water temperature at site 80904**

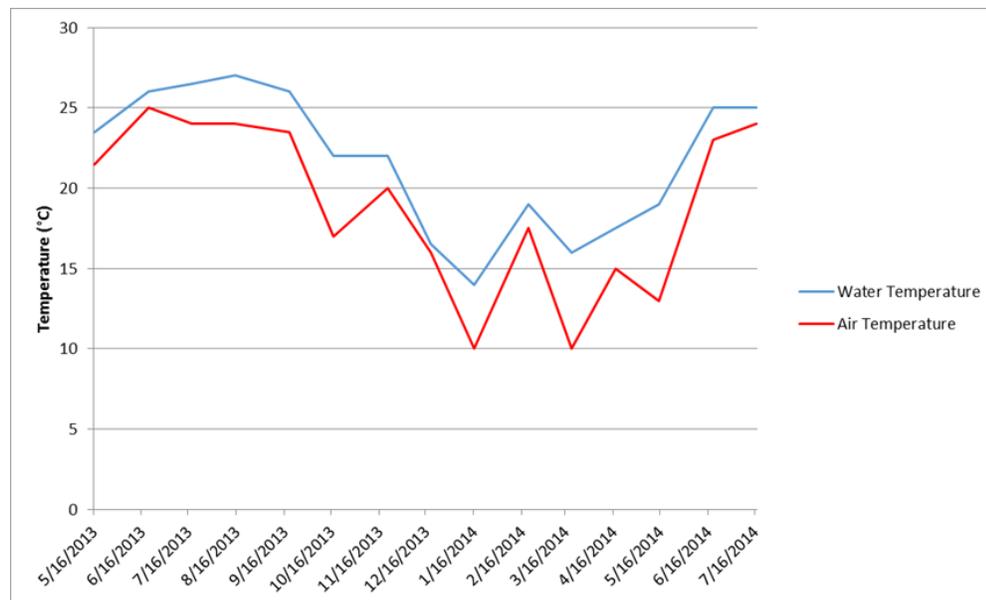
The air temperature varied from a low of 10°C to a high of 25°C in June of 2013.

Figure 33: Air and water temperature at Site 80966
