SHOAL CREEK WATERSHED DATA REPORT

March 2022

THE MEADOWS CENTER
FOR WATER AND THE ENVIRONMENT
TEXAS STATE UNIVERSITY

TEXAS STREAM TEAM

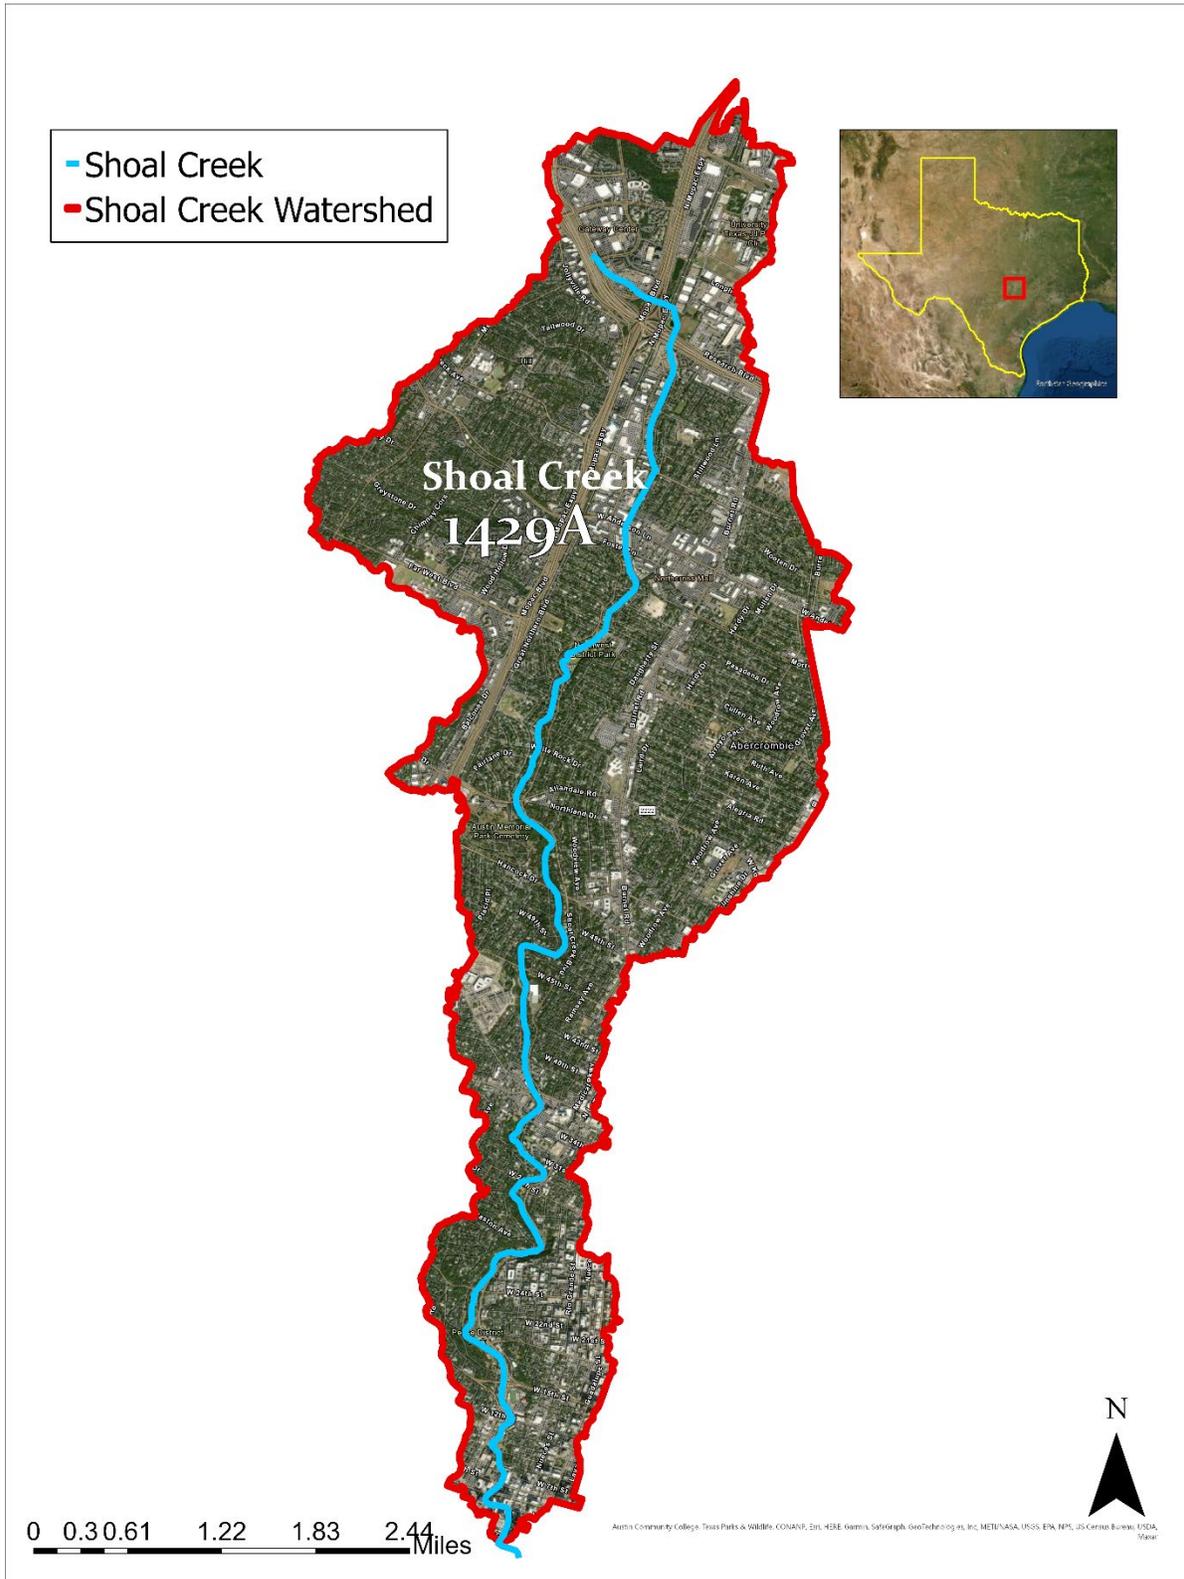
Figure 1. Shoal Creek within the Shoal Creek Watershed in Travis County.

Shoal Creek is an urbanized stream whose 13-square-mile watershed, the Town Lake-Colorado River Watershed, lies within Austin, Texas, in Travis County (Figure 1). The urban stream extends for 11 miles from northwest Austin through the center of the city to its confluence with Lady Bird Lake. This area is important locally for aesthetics, recreation, and for the ecosystem it supports. For the purposes of this report, the Town Lake-Colorado River Watershed will be referred to as the Shoal Creek Watershed throughout.
